**Flood Control Project Maintenance
Levee Inspections**

2015 Channel Summary Report

Merced Streams Group

Flood Control Project Maintenance**Unit Cover Sheet****2015 Channel Inspection Results****Merced Streams Group**

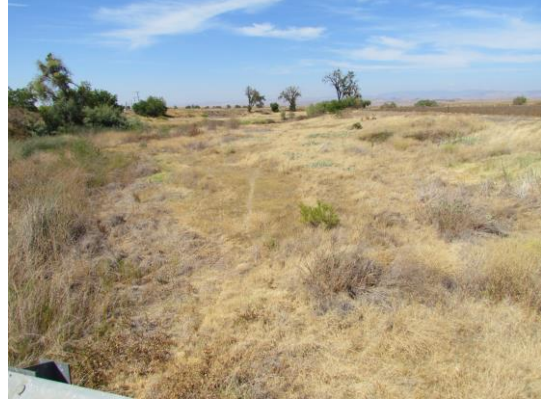
Photo 1 of 1 : CH_2015_NA0013_32_1_20150827_00021.jpg

Rating **	A	Issue No.	1	GPS Lat/Long
Issue Type +	Ma	Location *		37.336900 °
Category	Rivers, Channels & Designated Flood			-120.311100 °
Item	Vegetation & Obstructions			
DWR ID	DWR_NA0013_32_c _ 2012_1			
Action/Comments				
Inspector Comments: There is very little growth in the channel mostly dry grasses at this location.

Looking upstream from Bonner Road bridge crossing the Bear Creek.

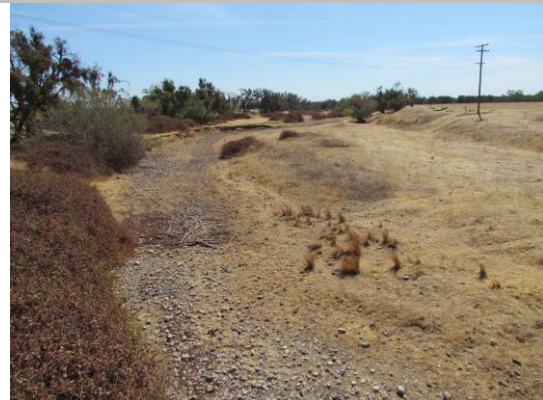
Photo 1 of 1 : CH_2015_NA0013_32_6_20150827_00022.jpg

Inspector Comments: There is no growth in the channel that would impede the flow.

Bonner Road crossing the Bear Creek looking downstream.

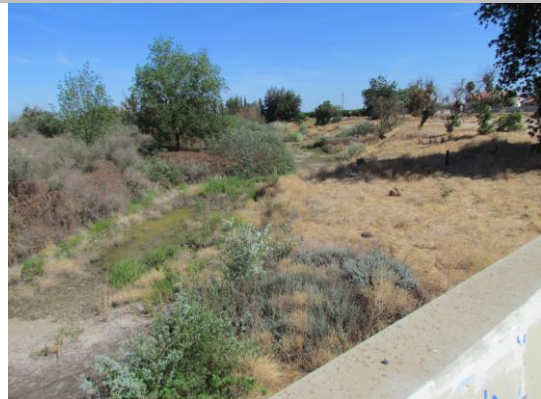
Photo 1 of 1 : CH_2015_NA0013_32_21_20150827_00023.jpg

Check Point / View				
Arboleda Dr / Up				
Rating **	M	Issue No.	21	GPS Lat/Long
Issue Type +	Ma	Location *		37.310805
Category	Rivers, Channels & Designated Flood			-120.378733
Item	Vegetation & Obstructions			
DWR ID	DWR_NA0013_32_c _ 2012_21			
Action/Comments				
Inspector Comments: There is some vegetation in the main channel that won't impede the flow.

Arboleda Drive crossing Bear Creek looking upstream.

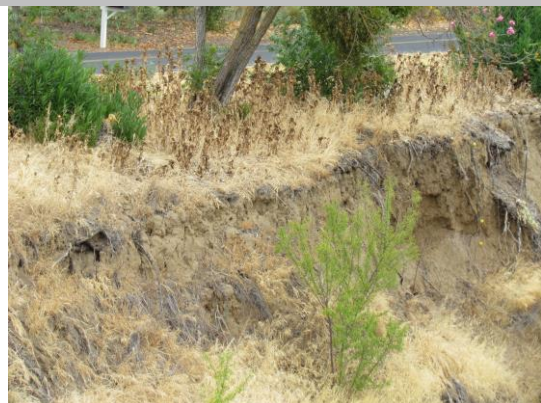
Photo 1 of 1 : CH_2015_NA0013_32_43_20150828_00029.jpg

Rating **	U	Issue No.	43	GPS Lat/Long
Issue Type +	En	Location *		37.309600 °
Category	Rivers, Channels & Designated Flood			-120.444500 °
Item	Erosion / Bank Caving			
DWR ID	DWR_NA0013_32_c _ 2012_43			
Action/Comments				
Inspector Comments: Apparent head cutting and horizontal deviation of more than 1 foot from designed grade or cross section. Corrective actions required to stop or slow erosion. 37.309674,-120.443784

Bear Creek looking upstream from McKee Road crossing.

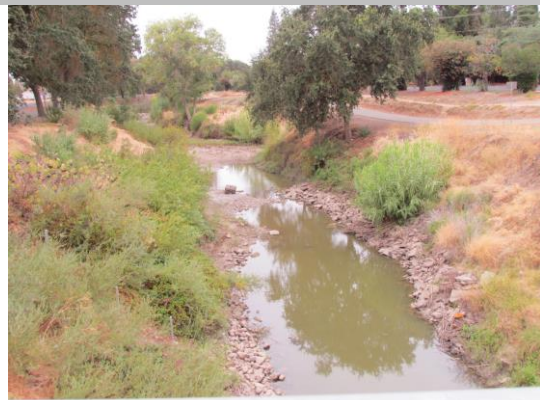
Photo 1 of 1 : CH_2015_NA0013_32_46_20150828_00031.jpg

Inspector Comments: The vegetation here is along the left bank and there is none in the channel.

Bear Creek downstream from McKee Rd crossing.

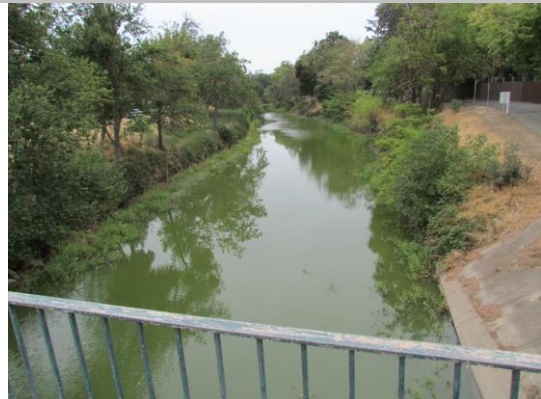
Photo 1 of 1 : CH_2015_NA0013_32_51_20150828_00032.jpg

Check Point / View				
R St / Up				
Rating **	A	Issue No.	51	GPS Lat/Long
Issue Type +	Ma	Location *		37.313400 °
Category	Rivers, Channels & Designated Flood			-120.487500 °
Item	Vegetation & Obstructions			
DWR ID	DWR_NA0013_32_c _ 2012_51			
Action/Comments				
Inspector Comments: The channel is clear of vegetation and there are no obstructions.

Bear Creek looking upstream from R Street crossing.

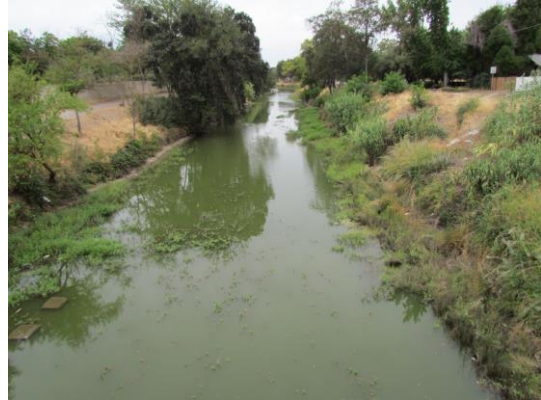
Photo 1 of 1 : CH_2015_NA0013_32_56_20150828_00033.jpg

Rating **	A	Issue No.	56	GPS Lat/Long
Issue Type +	Ma	Location *		37.313400 °
Category	Rivers, Channels & Designated Flood			-120.487500 °
Item	Vegetation & Obstructions			
DWR ID	DWR_NA0013_32_c _ 2012_56			
Action/Comments				
Inspector Comments: No vegetation in the channel.

Bear Creek looking downstream from R Street bridge crossing.

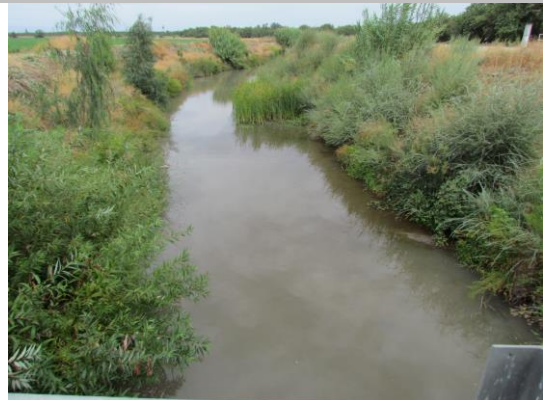
Photo 1 of 1 : CH_2015_NA0013_32_61_20150828_00034.jpg

Bear Creek Looking upstream from Franklin Road crossing.

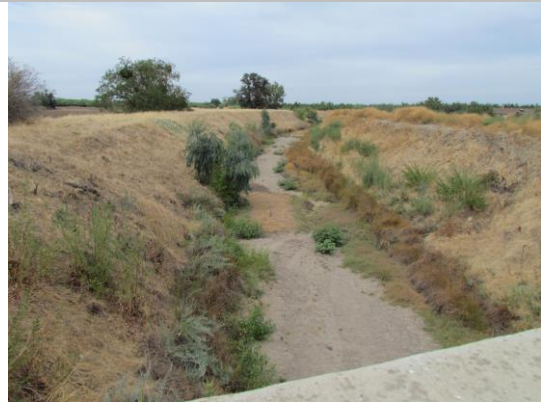
Photo 1 of 1 : CH_2015_NA0013_32_71_20150828_00036.jpg

Rating **	A	Issue No.	71	GPS Lat/Long
Issue Type +	Ma	Location *		37.302500
Category	Rivers, Channels & Designated Flood			-120.551500
Item	Vegetation & Obstructions			
DWR ID	DWR_NA0013_32_c _ 2012_71			
Action/Comments				
Inspector Comments: No vegetation in channel during this inspection.

Bear Creek looking upstream from Hwy 140 bridge crossing.

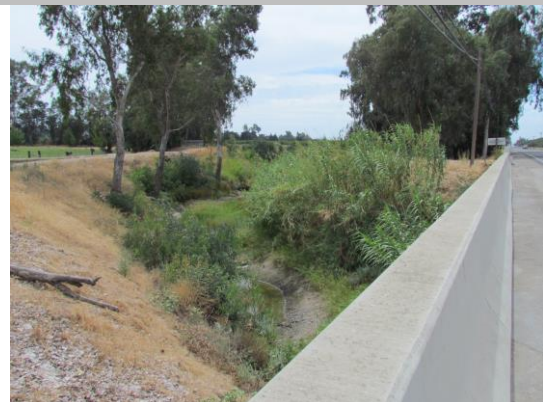
Photo 1 of 1 : CH_2015_NA0013_32_76_20150828_00038.jpg

Check Point / View				
Hwy 140 / Down				
Rating **	M	Issue No.	76	GPS Lat/Long
Issue Type +	Ma	Location *		37.302500
Category	Rivers, Channels & Designated Flood			-120.551500
Item	Vegetation & Obstructions			
DWR ID	DWR_NA0013_32_c _ 2012_76			
Action/Comments				
Inspector Comments: Log jams, snags, vegetation growth (such as cat tails, bull rushes, bushes or saplings) or other obstructions block approximately 25% of the FCW.

Bear Creek looking downstream from Hwy 140 bridge crossing.

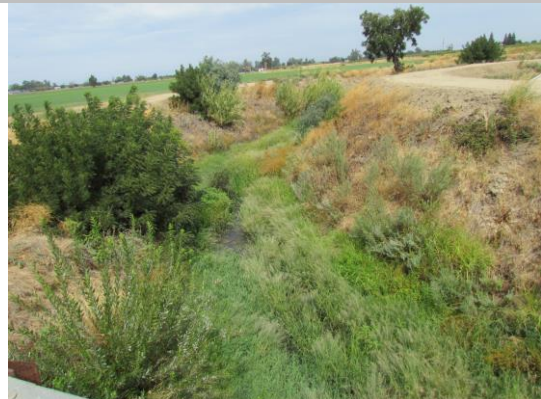
Photo 1 of 1 : CH_2015_NA0013_32_81_20150828_00039.jpg

Check Point / View				
Buhach Rd / Up				
Rating **	M	Issue No.	81	GPS Lat/Long
Issue Type +	Ma	Location *		37.291200 °
Category	Rivers, Channels & Designated Flood			-120.577900 °
Item	Vegetation & Obstructions			
DWR ID	DWR_NA0013_32_c _ 2012_81			
Action/Comments				
Inspector Comments: There is vegetation in the channel at this location, flow is not impeded.

Bear Creek looking upstream from Buhach Road crossing.

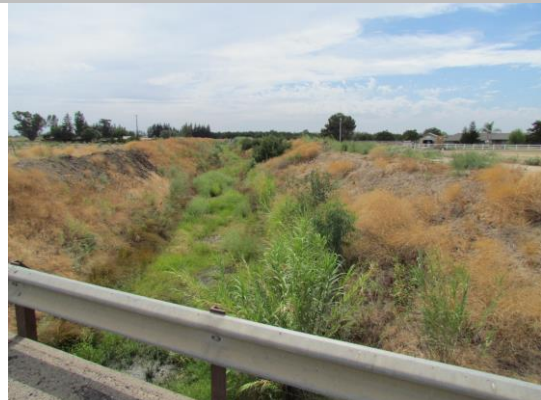
Photo 1 of 1 : CH_2015_NA0013_32_86_20150828_00040.jpg

Inspector Comments: Channel does have some vegetation present but the flow will not be impeded.

Bear Creek looking downstream from Buhach Road crossing.

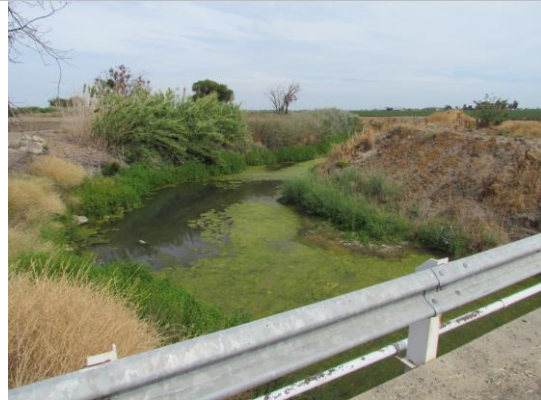
Photo 1 of 1 : CH_2015_NA0013_32_101_20150828_00041.jpg

Check Point / View				
Bert Crane Rd / Up				
Rating **	A	Issue No.	101	GPS Lat/Long
Issue Type +	Ma	Location *		37.256440 °
Category	Rivers, Channels & Designated Flood			-120.651870 °
Item	Vegetation & Obstructions			
DWR ID	DWR_NA0013_32_c _ 2012_101			
Action/Comments				
Inspector Comments: Very little vegetation in channel at this location. Flow is not impeded.

Bear Creek looking upstream from Bert Crane Road crossing. 37.25644,-120.65187

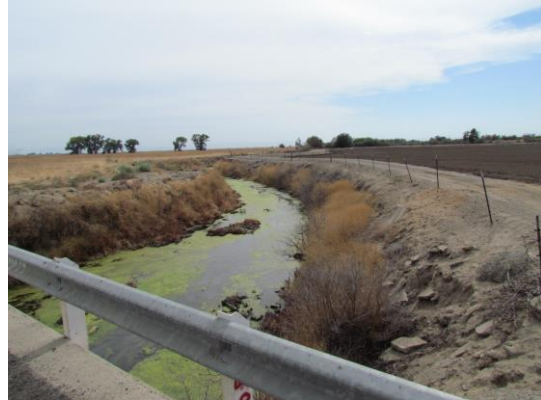
Photo 1 of 1 : CH_2015_NA0013_32_106_20150828_00042.jpg

Rating **	A	Issue No.	106	GPS Lat/Long
Issue Type +	Ma	Location *		37.256440 °
Category	Rivers, Channels & Designated Flood			-120.651870 °
Item	Vegetation & Obstructions			
DWR ID	DWR_NA0013_32_c_2012_106			
Action/Comments				
Inspector Comments: There is no vegetation in channel that impedes the flow in channel.

Bear Creek looking downstream from Bert Crane Road crossing.
37.25644,-120.65187

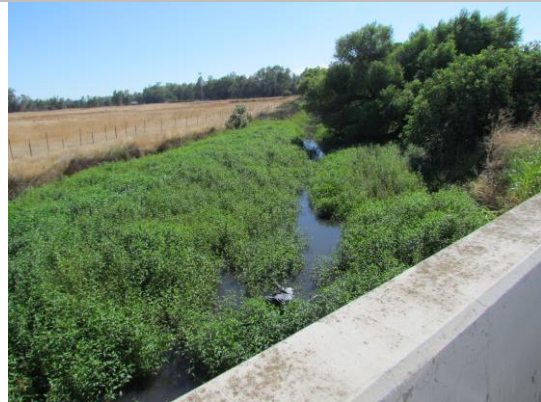
Photo 1 of 1 : CH_2015_NA0013_33_1_20150820_00021.jpg

Rating **	U	Issue No.	1	GPS Lat/Long
Issue Type +	Ma	Location *		37.320720 °
Category	Rivers, Channels & Designated Flood			-120.508760 °
Item	Vegetation & Obstructions			
DWR ID	DWR_NA0013_33_c _ 2012_1			
Action/Comments				
Inspector Comments: Vegetation growth (such as cat tails, bull rushes, bushes or saplings) or other obstructions block approximate 50% of the capacity.

Santa Fe Drive crossing the Black Rascal Creek looking upstream of channel.

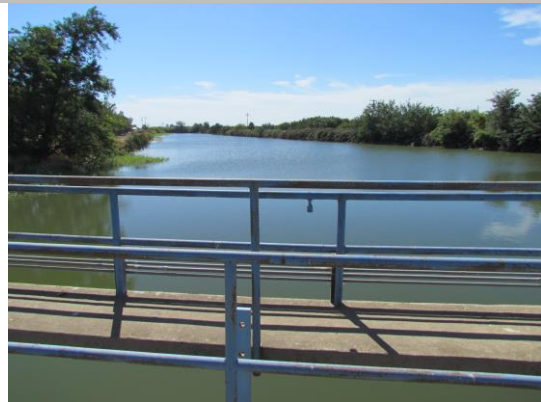
Photo 1 of 1 : CH_2015_NA0013_33_11_20150820_00023.jpg

Check Point / View				
Crocker Dam / Up				
Rating **	A	Issue No.	11	GPS Lat/Long
Issue Type +	Ma	Location *		37.312200 °
Category	Rivers, Channels & Designated Flood			-120.533000 °
Item	Vegetation & Obstructions			
DWR ID	DWR_NA0013_33_c _ 2012_11			
Action/Comments				
Inspector Comments: No vegetation observed in channel at this location.

Looking upstream from the Crocker Dam crossing the Black Rascal Creek.

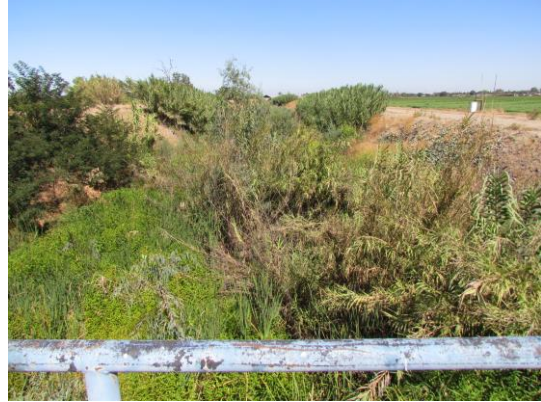
Photo 1 of 1 : CH_2015_NA0013_33_16_20150820_00025.jpg

Rating **	U	Issue No.	16	GPS Lat/Long
Issue Type +	Ma	Location *		37.312200 °
Category	Rivers, Channels & Designated Flood			-120.533000 °
Item	Vegetation & Obstructions			
DWR ID	DWR_NA0013_33_c _ 2012_16			
Action/Comments				
Inspector Comments: Wild growth present in channel and on both banks.

Black Rascal Creek downstream from Crocker Dam.

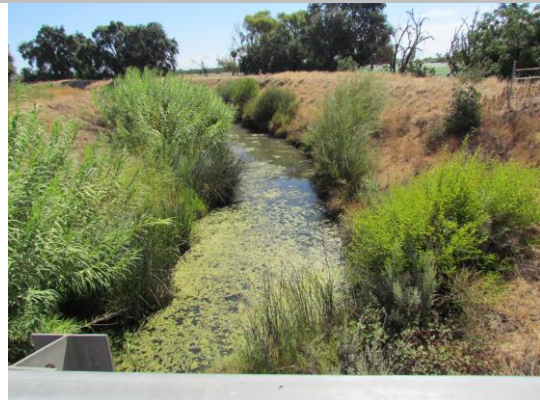
Photo 1 of 1 : CH_2015_NA0013_33_21_20150820_00026.jpg

Inspector Comments: Log jams, snags, vegetation growth (such as cat tails, bull rushes, bushes or saplings) or other obstructions block less than 25% of the capacity.

Black Rascal Creek looking upstream from the Franklin Road crossing.

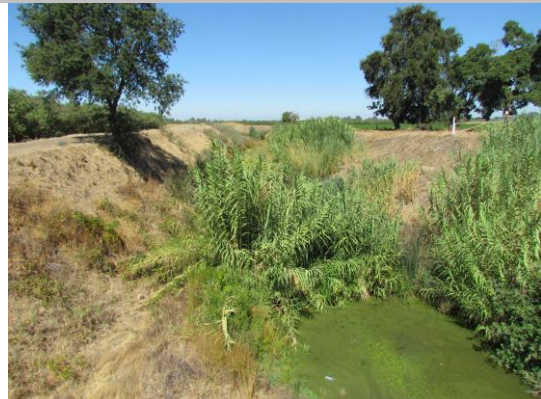
Photo 1 of 1 : CH_2015_NA0013_33_26_20150820_00027.jpg

Check Point / View				
Franklin Rd / Down				
Rating **	U	Issue No.	26	GPS Lat/Long
Issue Type +	Ma	Location *		37.314050 °
Category	Rivers, Channels & Designated Flood			-120.541078 °
Item	Vegetation & Obstructions			
DWR ID	DWR_NA0013_33_c _ 2012_26			
Action/Comments				
Inspector Comments: Vegetation is present on both banks of the Black Rascal Creek. Bambo growth increased from last inspection.

Black Rascal Creek looking downstream from Franklin Road crossing.

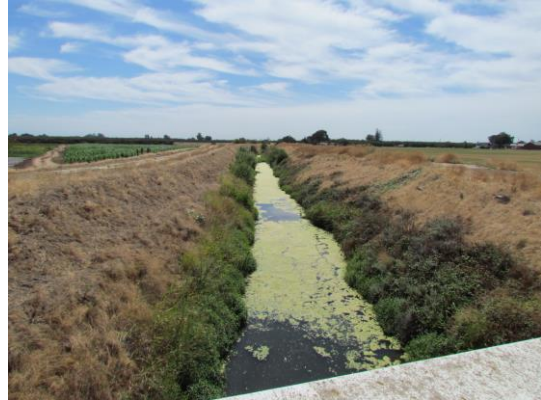
Photo 1 of 1 : CH_2015_NA0013_33_31_20150820_00028.jpg

Rating **	A	Issue No.	31	GPS Lat/Long
Issue Type +	Ma	Location *		37.313110 °
Category	Rivers, Channels & Designated Flood			-120.559070 °
Item	Vegetation & Obstructions			
DWR ID	DWR_NA0013_33_c _ 2012_31			
Action/Comments				
Inspector Comments: Minimal, scattered obstructions of vegetation. The flow is not impeded.

Black Rascal Creek looking upstream from Gurr Road crossing.

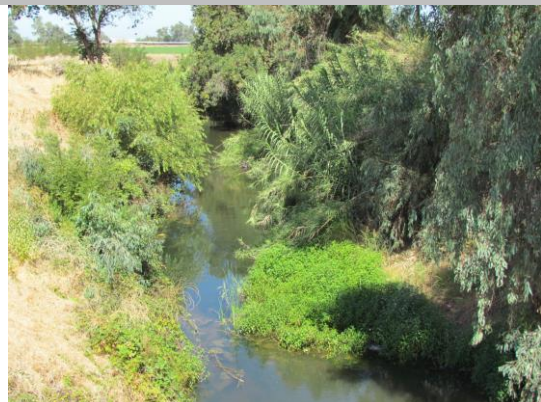
Photo 1 of 1 : CH_2015_NA0013_33_36_20150820_00029.jpg

Black Rascal Creek looking downstream from Gurr Road crossing.

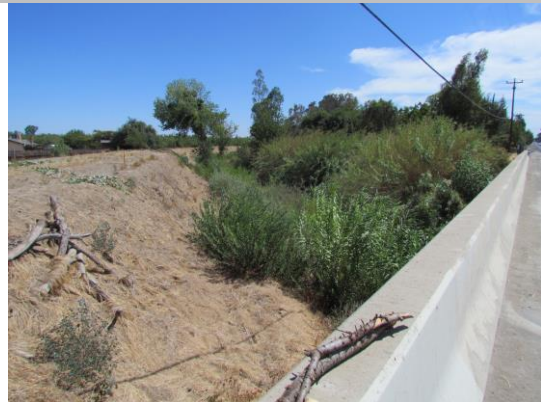
Photo 1 of 1 : CH_2015_NA0013_33_41_20150820_00030.jpg

Check Point / View				
Hwy 140 / Up				
Rating **	M	Issue No.	41	GPS Lat/Long
Issue Type +	Ma	Location *		37.302400 °
Category	Rivers, Channels & Designated Flood			-120.575460 °
Item	Vegetation & Obstructions			
DWR ID	DWR_NA0013_33_c _ 2012_41			
Action/Comments				
Inspector Comments: Log jams, snags, vegetation growth (such as cat tails, bull rushes, bushes or saplings) or other obstructions block approximately 25% of the capacity.

Black Rascal Creek from the Hwy 140 crossing the channel.

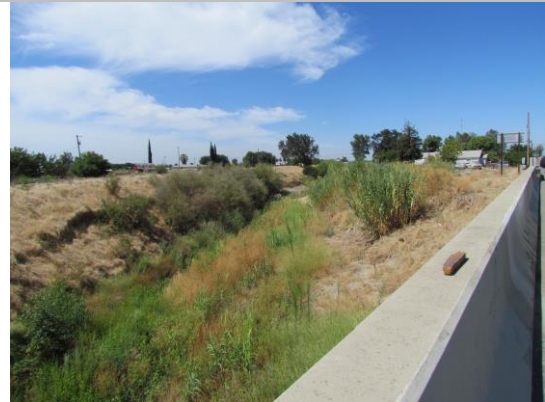
Photo 1 of 1 : CH_2015_NA0013_33_46_20150826_00031.jpg

Rating **	M	Issue No.	46	GPS Lat/Long
Issue Type +	Ma	Location *		37.302400
Category	Rivers, Channels & Designated Flood			-120.575460
Item	Vegetation & Obstructions			
DWR ID	DWR_NA0013_33_c _ 2012_46			
Action/Comments				
Inspector Comments: Vegetation in the channel along both banks. The flow is not impeded.

Black Rascal Creek looking downstream from Hwy 140 crossing.

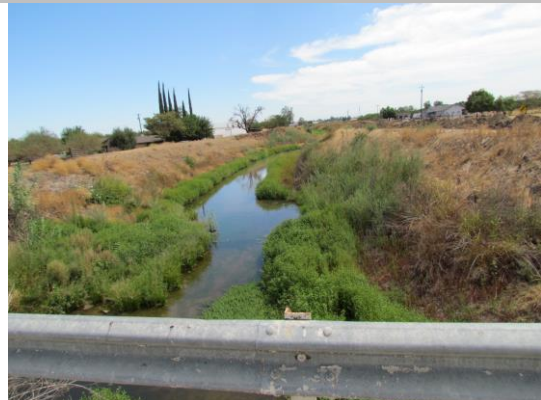
Photo 1 of 1 : CH_2015_NA0013_33_51_20150826_00032.jpg

Black Rascal Creek from Quinley Road crossing.

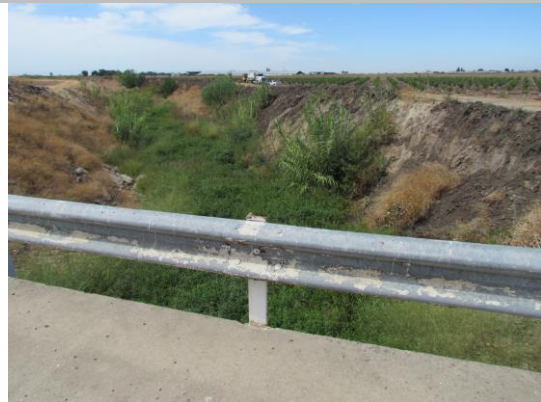
Photo 1 of 1 : CH_2015_NA0013_33_56_20150826_00033.jpg

Inspector Comments: Vegetation present in channel downstream from bridge crossing.

Black Rascal Creek from Quinley Rd crossing looking downstream.

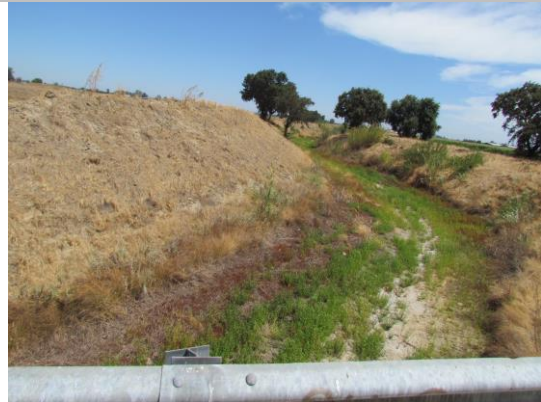
Photo 1 of 1 : CH_2015_NA0013_33_61_20150826_00034.jpg

Rating **	A	Issue No.	61	GPS Lat/Long
Issue Type +	Ma	Location *		37.280330 °
Category	Rivers, Channels & Designated Flood			-120.609400 °
Item	Vegetation & Obstructions			
DWR ID	DWR_NA0013_33_c _ 2012_61			
Action/Comments				
Inspector Comments: No unsatisfactory vegetation at this location.

Black Rascal Creek from Oak Avenue crossing the channel.

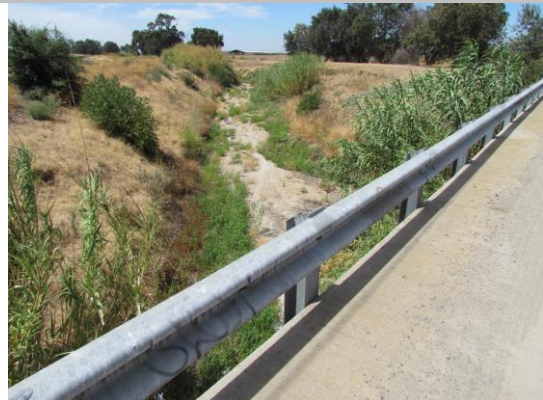
Photo 1 of 1 : CH_2015_NA0013_33_66_20150826_00036.jpg

Black Rascal Creek looking downstream from Oak Avenue crossing

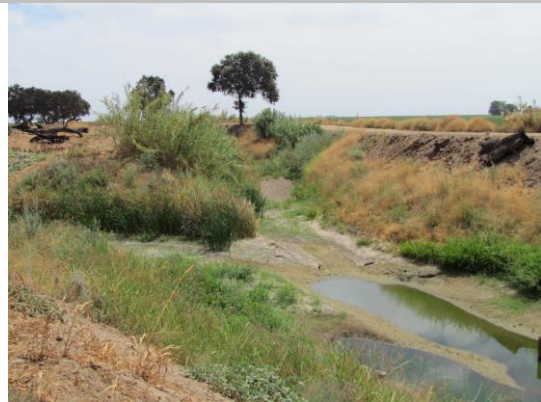
Photo 1 of 1 : CH_2015_NA0013_33_71_20150826_00038.jpg

Check Point / View				
Bear Creek Confluence / Up				
Rating **	M	Issue No.	71	GPS Lat/Long
Issue Type +	Ma	Location *		37.268311 °
Category	Rivers, Channels & Designated Flood			-120.624111 °
Item	Vegetation & Obstructions			
DWR ID	DWR_NA0013_33_c _ 2012_71			
Action/Comments				
Inspector Comments: Vegetation present upstream at the confluence. Flow is not impeded.

Looking at the confluence of the Black Rascal Creek and the Bear Creek, viewed from downstream right bank of the Black Rascal Creek.

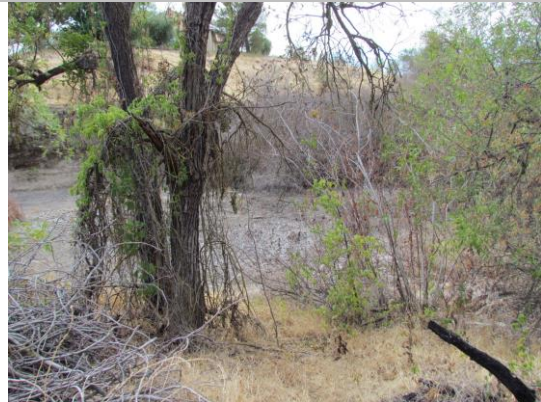
Photo 1 of 1 : CH_2015_NA0013_34_11_20150819_00003.jpg

Rating **	A	Issue No.	11	GPS Lat/Long
Issue Type +	Ma	Location *		37.333747 °
Category	Rivers, Channels & Designated Flood			-120.318622 °
Item	Vegetation & Obstructions			
DWR ID	DWR_NA0013_34_c_2012_11			
Action/Comments				
Inspector Comments: The Burns Creek has limited access,only able to view it at (2) locations, low water crossing, and the confluence.

View of the Burns Creek at the confluence with Bear Creek. 37.333527,-120.320610

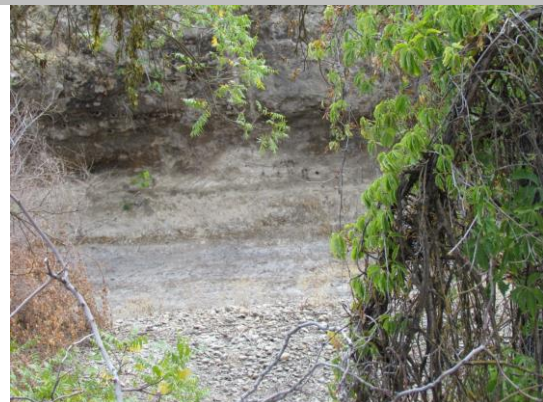
Photo 1 of 1 : CH_2015_NA0013_34_21_20150819_00004.jpg

Inspector Comments: Minimal, scattered vegetation present. The flow is not impeded.

Low water crossing upstream of the confluence. 37.333747,-120.318622

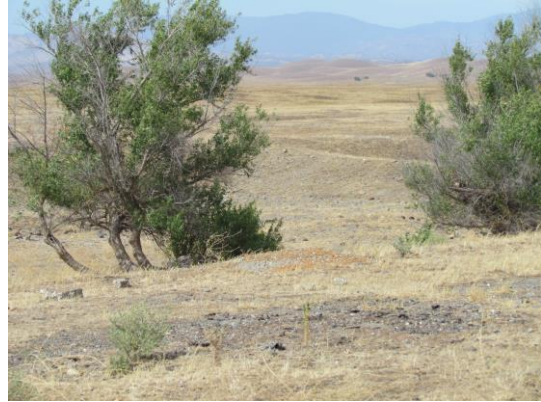
Photo 1 of 1 : CH_2015_NA0013_35_1_20150826_00025.jpg

Rating **	A	Issue No.	1	GPS Lat/Long
Issue Type +	Ma	Location *		37.261425 °
Category	Rivers, Channels & Designated Flood			-120.198078 °
Item	Vegetation & Obstructions			
DWR ID	DWR_NA0013_35_c _ 2012_1			
Action/Comments				
Inspector Comments: No vegetation in channel.

Mariposa Creek looking upstream from White Rock Road.

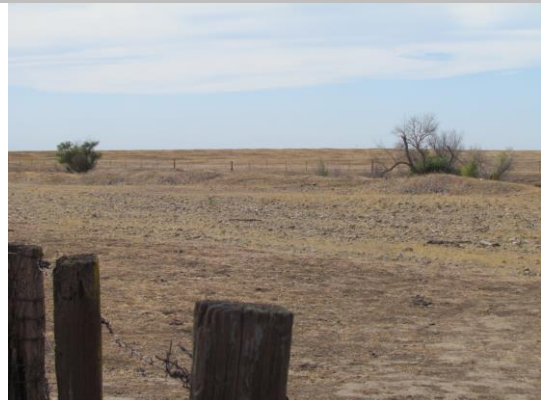
Photo 1 of 1 : CH_2015_NA0013_35_6_20150826_00026.jpg

Inspector Comments: No vegetation in channel.

Mariposa Creek looking downstream from White Rock Road.

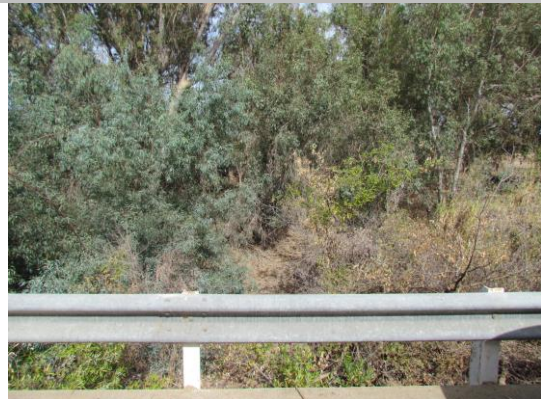
Photo 1 of 1 : CH_2015_NA0013_35_11_20150826_00027.jpg

Check Point / View				
Fresno Rd / Up				
Rating **	U	Issue No.	11	GPS Lat/Long
Issue Type +	Ma	Location *		37.238030 °
Category	Rivers, Channels & Designated Flood			-120.243520 °
Item	Vegetation & Obstructions			
DWR ID	DWR_NA0013_35_c _ 2012_11			
Action/Comments				
Inspector Comments: Log jams, snags, vegetation growth (such as cat tails, bull rushes, bushes or saplings) or other obstructions block approximately 50% of the capacity.

Mariposa Creek looking upstream from Fresno Road crossing.

Rating **	U	Issue No.	12	GPS Lat/Long
Issue Type +	Ma	Location *		37.238030 °
Category	Rivers, Channels & Designated Flood			-120.243520 °
Item	Shoaling / Sedimentation			
DWR ID	DWR_NA0013_35_c _ 2012_12			
Action/Comments				
Inspector Comments: Channel is choked off with vegetation. Refer to photo of issue 12.

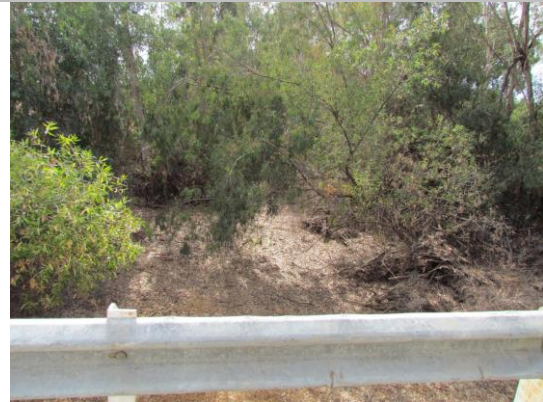
Photo 1 of 1 : CH_2015_NA0013_35_16_20150826_00028.jpg

Rating **	U	Issue No.	16	GPS Lat/Long
Issue Type +	Ma	Location *		37.238030 °
Category	Rivers, Channels & Designated Flood			-120.243520 °
Item	Vegetation & Obstructions			
DWR ID	DWR_NA0013_35_c _ 2012_16			
Action/Comments				
Inspector Comments: Log jams, snags, vegetation growth (such as cat tails, bull rushes, bushes or saplings) or other obstructions block approximately 50% of the capacity.

Mariposa Creek looking downstream from Fresno Road crossing.

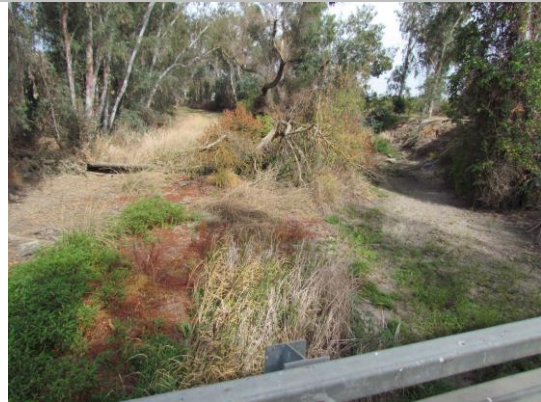
Photo 1 of 1 : CH_2015_NA0013_35_21_20150826_00029.jpg

Rating **	M	Issue No.	21	GPS Lat/Long
Issue Type +	Ma	Location *		37.238920 °
Category	Rivers, Channels & Designated Flood			-120.252550 °
Item	Vegetation & Obstructions			
DWR ID	DWR_NA0013_35_c _ 2012_21			
Action/Comments				
Inspector Comments: Vegetation present in channel.

Mariposa Creek looking upstream from Cuningham Road Crossing.

Rating **	M	Issue No.	22	GPS Lat/Long
Issue Type +	Ma	Location *		37.238920 °
Category	Rivers, Channels & Designated Flood			-120.252550 °
Item	Shoaling / Sedimentation			
DWR ID	DWR_NA0013_35_c _ 2012_22			
Action/Comments				
Inspector Comments: Non-aquatic grasses present on shoal. No trees or brush is present on shoal, and channel flow is not impeded. Refer to photo issue # 21.

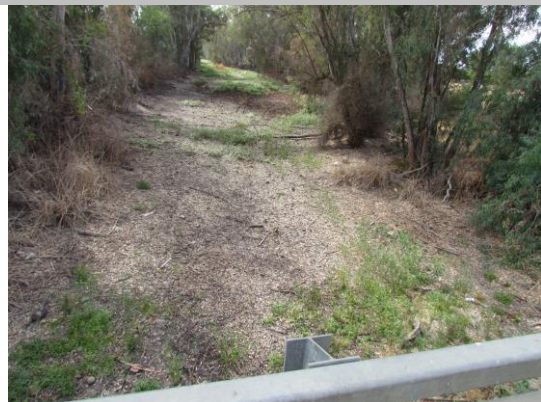
Photo 1 of 1 : CH_2015_NA0013_35_26_20150826_00030.jpg

Mariposa Creek looking downstream from Cunningham Road bridge crossing.

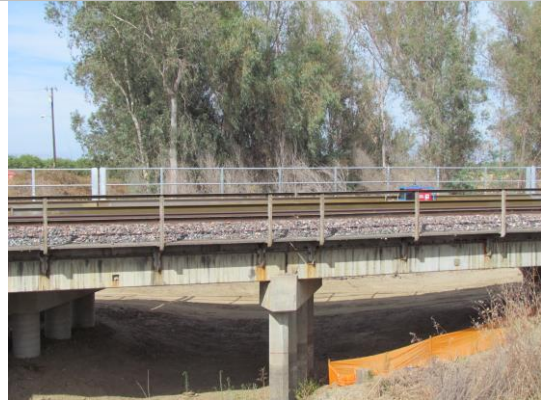
Photo 1 of 1 : CH_2015_NA0013_35_31_20150826_00031.jpg

Check Point / View				
RR Bridge near Santa Fe Dr / Up				
Rating **	A	Issue No.	31	GPS Lat/Long
Issue Type +	Ma	Location *		37.239220 °
Category	Rivers, Channels & Designated Flood			-120.259020 °
Item	Vegetation & Obstructions			
DWR ID	DWR_NA0013_35_c _ 2012_31			
Action/Comments				
Inspector Comments: Minimal, scattered obstructions or vegetation. The flow is not impeded.

Mariposa Creek looking upstream from Santa Fe Drive crossing.

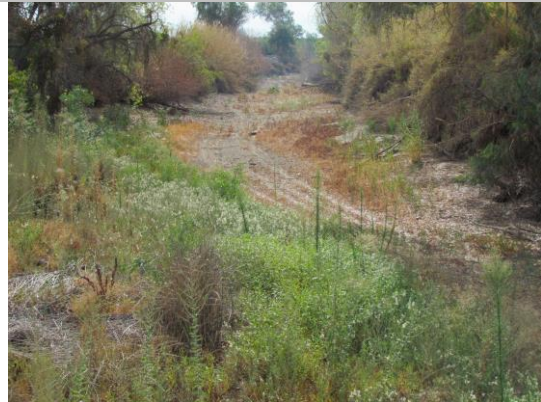
Photo 1 of 1 : CH_2015_NA0013_35_36_20150826_00032.jpg

Rating **	A	Issue No.	36	GPS Lat/Long
Issue Type +	Ma	Location *		37.239220 °
Category	Rivers, Channels & Designated Flood			-120.259020 °
Item	Vegetation & Obstructions			
DWR ID	DWR_NA0013_35_c _ 2012_36			
Action/Comments				
Inspector Comments: Minimal, scattered obstructions or vegetation. The flow is not impeded.

Mariposa Creek looking downstream from Santa Fe Bridge crossing.

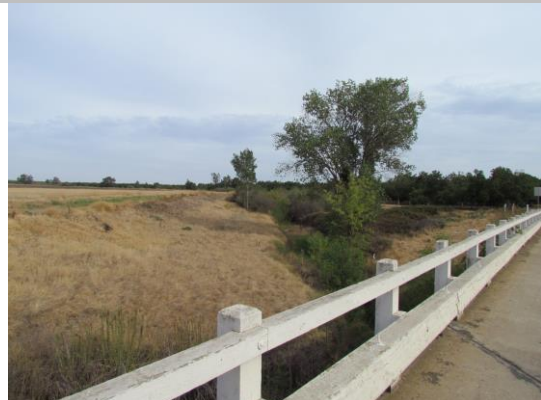
Photo 1 of 1 : CH_2015_NA0013_35_41_20150826_00033.jpg

Inspector Comments: Minimal, scattered obstructions of vegetation present. The flow is not impeded.

Mariposa Creek looking upstream from Burchell Road crossing.

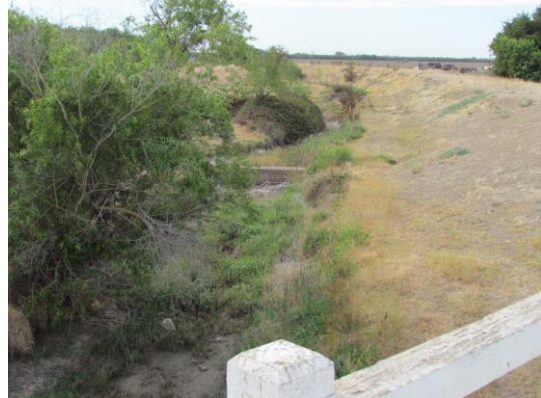
Photo 1 of 1 : CH_2015_NA0013_35_46_20150827_00035.jpg

Inspector Comments: No vegetation problems. The flow is not impeded.

Mariposa Creek looking downstream from Burchell Road crossing.

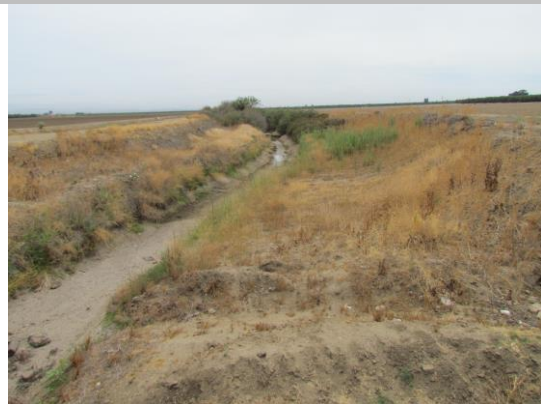
Photo 1 of 1 : CH_2015_NA0013_35_51_20150827_00036.jpg

Inspector Comments: Minimal, scattered obstructions or vegetation. The flow is not impeded.

Mariposa Creek looking upstream from Plainsburg Road Crossing.

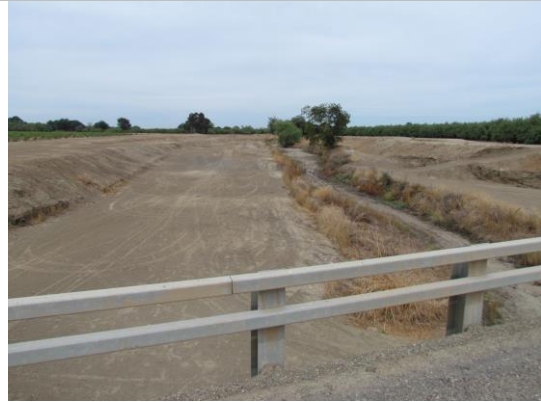
Photo 1 of 1 : CH_2015_NA0013_35_56_20150827_00037.jpg

Mariposa Creek looking downstream from Plainsburg Road Crossing.

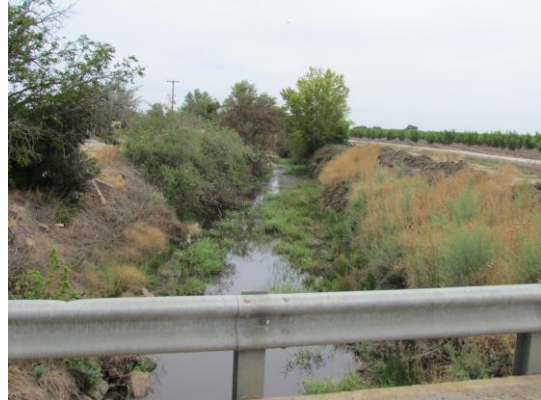
Photo 1 of 1 : CH_2015_NA0013_35_61_20150827_00038.jpg

Rating **	M	Issue No.	61	GPS Lat/Long
Issue Type +	Ma	Location *		37.261540 °
Category	Rivers, Channels & Designated Flood			-120.343200 °
Item	Vegetation & Obstructions			
DWR ID	DWR_NA0013_35_c _ 2012_61			
Action/Comments				
Inspector Comments: Log jams, snags, vegetation growth (such as cat tails, bull rushes, bushes or saplings) or other obstructions block approximately 25% of the FCW.

Mariposa Creek looking upstream from Whealan Road crossing.

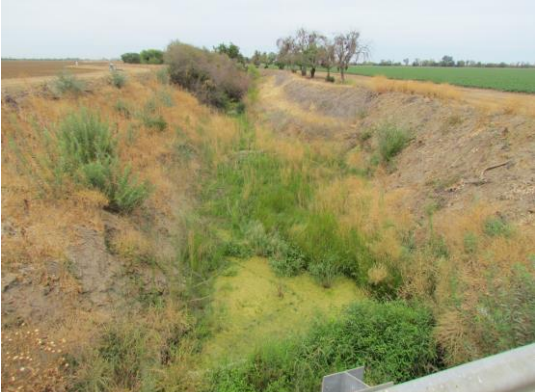
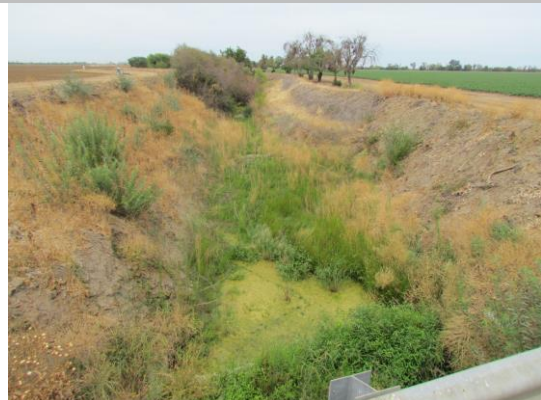
Photo 1 of 1 : CH_2015_NA0013_35_66_20150827_00039.jpg

Check Point / View				
Whealan Rd / Down				
Rating **	M	Issue No.	66	GPS Lat/Long
Issue Type +	Ma	Location *		37.261540 °
Category	Rivers, Channels & Designated Flood			-120.343200 °
Item	Vegetation & Obstructions			
DWR ID	DWR_NA0013_35_c _ 2012_66			
Action/Comments				
Inspector Comments: Log jams, snags, vegetation growth (such as cat tails, bull rushes, bushes or saplings) or other obstructions block approximately 25% of the FCW. Both banks covered with wild tree growth.

Mariposa Creek looking downstream from Whealan Road Crossing.

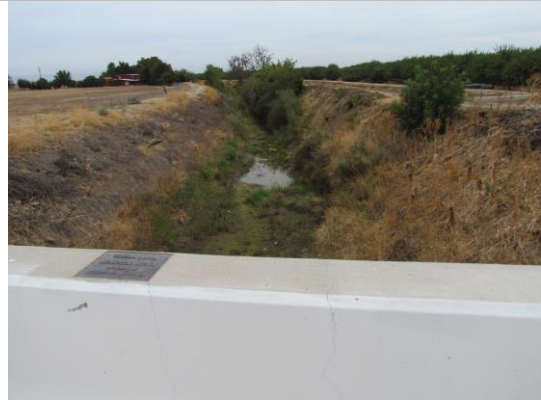
Photo 1 of 1 : CH_2015_NA0013_35_71_20150827_00042.jpg

Inspector Comments: Vegetation collection up on the left bank of channel, flow is not impeded.

Mariposa Creek looking upstream from Arboleda Road crossing.

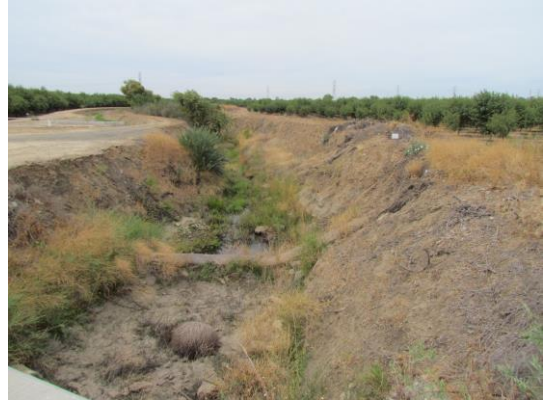
Photo 1 of 1 : CH_2015_NA0013_35_76_20150827_00041.jpg

Rating **	M	Issue No.	76	GPS Lat/Long
Issue Type +	Ma	Location *		37.257036 °
Category	Rivers, Channels & Designated Flood			-120.379219 °
Item	Vegetation & Obstructions			
DWR ID	DWR_NA0013_35_c _ 2012_76			
Action/Comments				
Inspector Comments: Log jams, snags, vegetation growth (such as cat tails, bull rushes, bushes or saplings) or other obstructions blocking approximately 25% of the capacity.

Mariposa Creek looking upstream from Arboleda Road crossing.

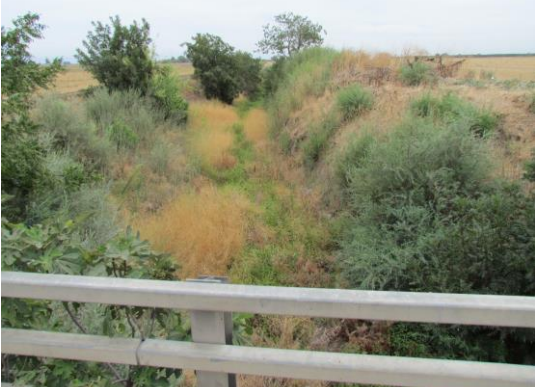
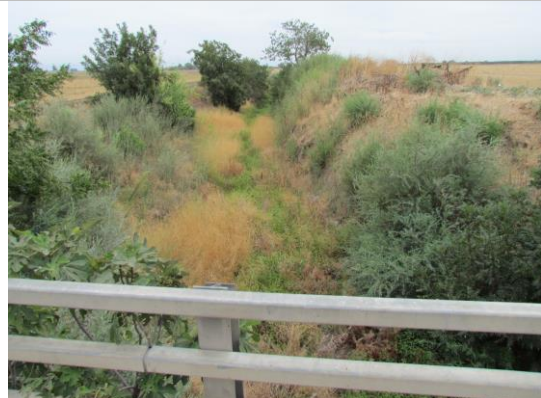
Photo 1 of 1 : CH_2015_NA0013_35_81_20150831_00049.jpg

Check Point / View				
Healy Rd / Up				
Rating **	U	Issue No.	81	GPS Lat/Long
Issue Type +	Ma	Location *		37.246180 °
Category	Rivers, Channels & Designated Flood			-120.434130 °
Item	Vegetation & Obstructions			
DWR ID	DWR_NA0013_35_c _ 2012_81			
Action/Comments				
Inspector Comments: Vegetation present on both banks and in channel.

Looking upstream from Healy Road crossing.

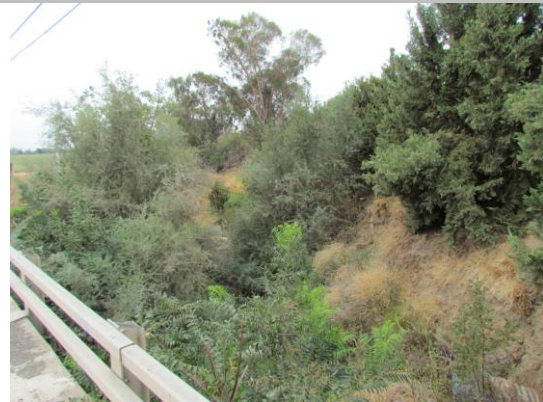
Photo 1 of 1 : CH_2015_NA0013_35_86_20150831_00050.jpg

Check Point / View				
Healy Rd / Down				
Rating **	M	Issue No.	86	GPS Lat/Long
Issue Type +	Ma	Location *		37.246180
Category	Rivers, Channels & Designated Flood			-120.434130
Item	Vegetation & Obstructions			
DWR ID	DWR_NA0013_35_c _ 2012_86			
Action/Comments				
Inspector Comments: Log jams, snags, vegetation growth (such as cat tails, bull rushes, bushes or saplings) or other obstructions block approximately 25% of the capacity.

Looking downstream from Healy Road crossing.

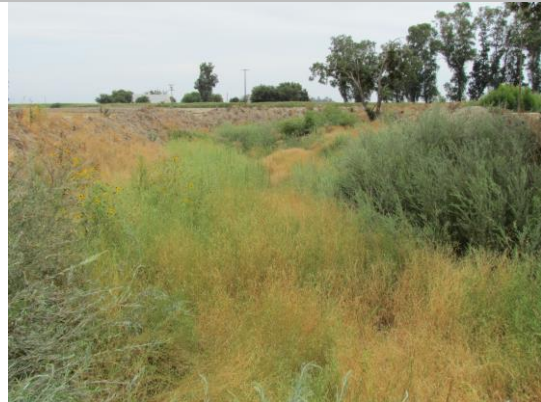
Photo 1 of 1 : CH_2015_NA0013_35_91_20150827_00046.jpg

Rating **	M	Issue No.	91	GPS Lat/Long
Issue Type +	Ma	Location *		37.233961 °
Category	Rivers, Channels & Designated Flood			-120.487872 °
Item	Vegetation & Obstructions			
DWR ID	DWR_NA0013_35_c _ 2012_91			
Action/Comments				
Inspector Comments: Log jams, snags, vegetation growth (such as cat tails, bull rushes, bushes or saplings) or other obstructions block approximately 25% of the capacity.

Mariposa Creek looking upstream from Hwy 59.

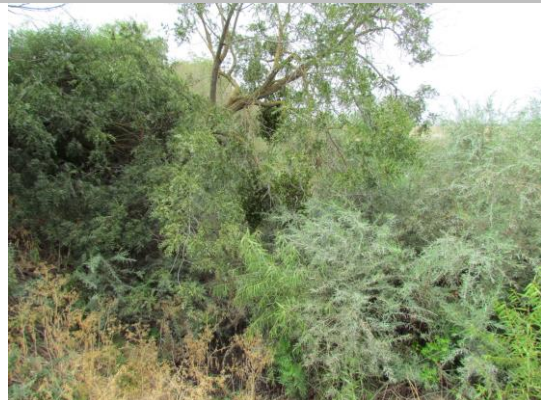
Photo 1 of 1 : CH_2015_NA0013_35_96_20150827_00047.jpg

Mariposa Creek looking downstream from Hwy 59.

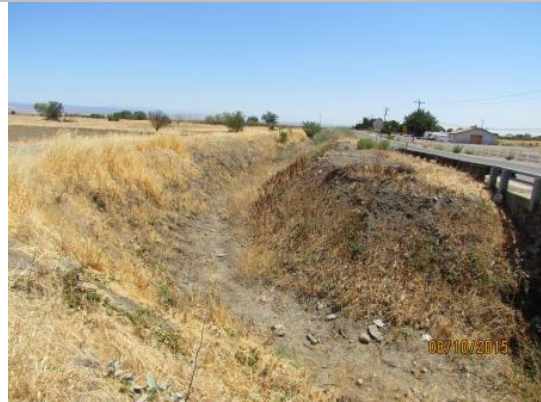
Photo 1 of 1 : CH_2015_NA0013_36_1_20150812_00030.jpg

Rating **	A	Issue No.	1	GPS Lat/Long
Issue Type +	Ma	Location *		37.287962 °
Category	Rivers, Channels & Designated Flood			-120.309167 °
Item	Vegetation & Obstructions			
DWR ID	DWR_NA0013_36_c _ 2012_1			
Action/Comments				
Inspector Comments: Some vegetation, but does not appear to be enough to impede flow.

Upstream view from the Childs Ave. crossing.

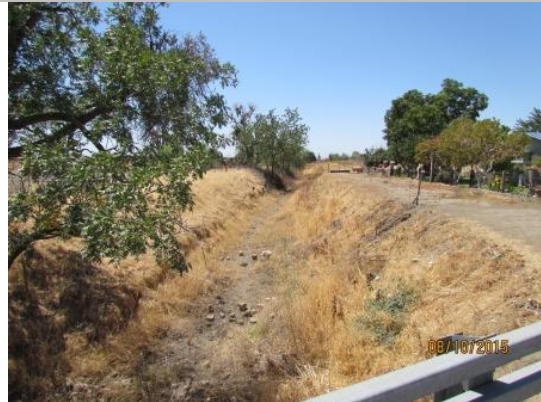
Photo 1 of 1 : CH_2015_NA0013_36_6_20150812_00032.jpg

Rating **	A	Issue No.	6	GPS Lat/Long
Issue Type +	Ma	Location *		37.287962 °
Category	Rivers, Channels & Designated Flood			-120.309170 °
Item	Vegetation & Obstructions			
DWR ID	DWR_NA0013_36_c _ 2012_6			
Action/Comments				
Inspector Comments: Some vegetation present, but does not appear to be enough to impede flow.

Downstream view from the Childs Ave. crossing.

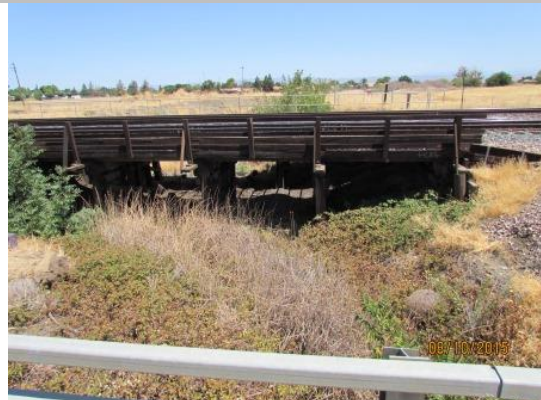
Photo 1 of 1 : CH_2015_NA0013_36_11_20150812_00034.jpg

Inspector Comments: Minor vegetation, but does not appear to be sufficient to impede flows.

View from the Santa Fe Dr. crossing looking upstream.

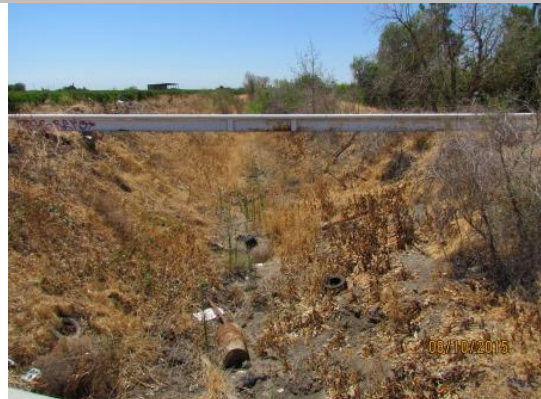
Photo 1 of 1 : CH_2015_NA0013_36_16_20150812_00035.jpg

Check Point / View				
Santa Fe Dr / Down				
Rating **	A	Issue No.	16	GPS Lat/Long
Issue Type +	Ma	Location *		37.284393
Category	Rivers, Channels & Designated Flood			-120.315460
Item	Vegetation & Obstructions			
DWR ID	DWR_NA0013_36_c _ 2012_16			
Action/Comments				
Inspector Comments: Minor vegetation, but does not appear to be sufficient to impede flows.

Santa Fe Dr. crossing downstream view.

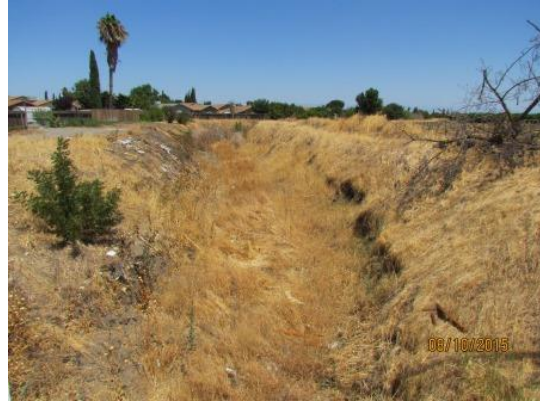
Photo 1 of 1 : CH_2015_NA0013_36_21_20150812_00036.jpg

Rating **	A	Issue No.	21	GPS Lat/Long
Issue Type +	Ma	Location *		37.282285 °
Category	Rivers, Channels & Designated Flood			-120.324890 °
Item	Vegetation & Obstructions			
DWR ID	DWR_NA0013_36_c _ 2012_21			
Action/Comments				
Inspector Comments: Minor vegetation, but does not appear as though it will impede flow.

Plainsburg Road crossing upstream view.

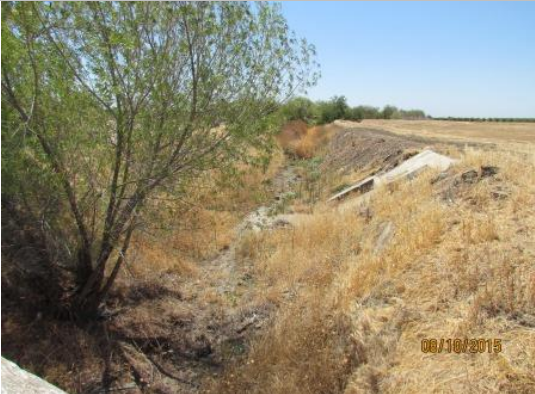
Photo 1 of 1 : CH_2015_NA0013_36_26_20150812_00037.jpg

Check Point / View				
Plainsburg Rd / Down				
Rating **	M	Issue No.	26	GPS Lat/Long
Issue Type +	Ma	Location *		37.282060 °
Category	Rivers, Channels & Designated Flood			-120.324870 °
Item	Vegetation & Obstructions			
DWR ID	DWR_NA0013_36_c _ 2012_26			
Action/Comments				
Inspector Comments: Trees are beginning to grow in channel. They appear to be a willow and a black walnut; please remove.

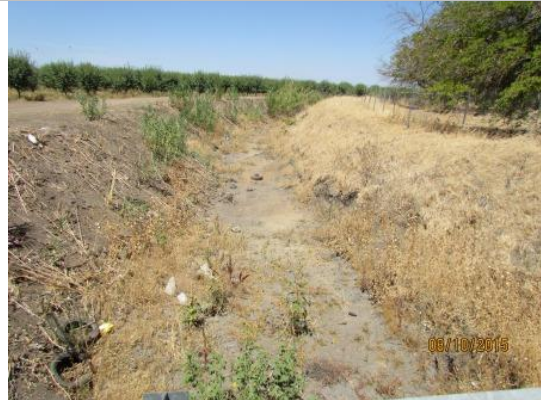
Photo 1 of 1 : CH_2015_NA0013_36_31_20150812_00038.jpg

Inspector Comments: Minor vegetation, but does not appear to be enough to impede flow.

Upstream view from Gerard Ave. crossing.

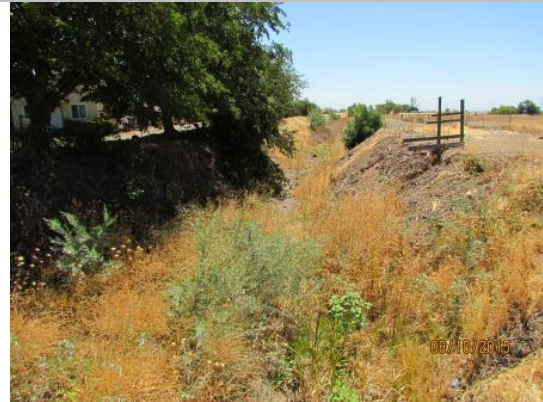
Photo 1 of 1 : CH_2015_NA0013_36_36_20150812_00039.jpg

Rating **	A	Issue No.	36	GPS Lat/Long
Issue Type +	Ma	Location *		37.280811
Category	Rivers, Channels & Designated Flood			-120.331170
Item	Vegetation & Obstructions			
DWR ID	DWR_NA0013_36_c _ 2012_36			
Action/Comments				
Inspector Comments: The LMA has removed most of the woody vegetation and the channel capacity appears to be restored.

Downstream view from Gerard Ave. crossing.

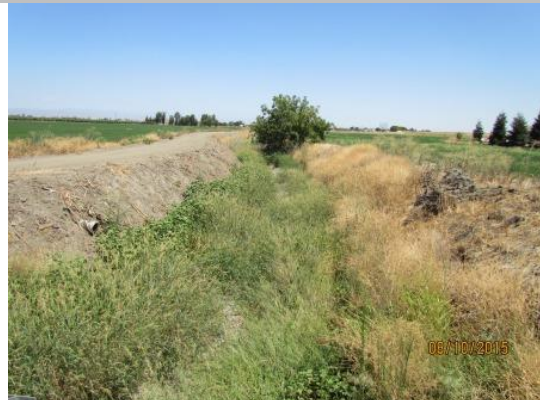
Photo 1 of 1 : CH_2015_NA0013_36_41_20150812_00040.jpg

Inspector Comments: Minimally obstructive vegetation present, but does not appear that it will impede flow.

Upstream view from Whealan Rd. crossing.

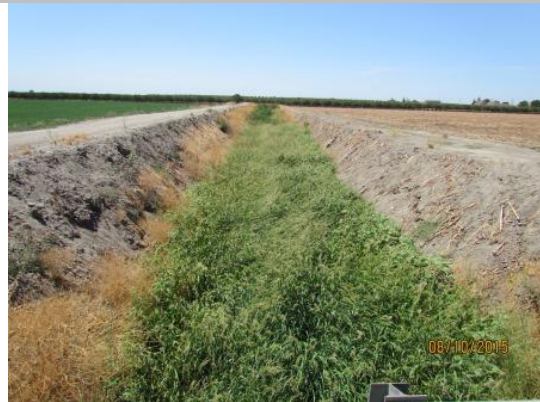
Photo 1 of 1 : CH_2015_NA0013_36_46_20150812_00041.jpg

Inspector Comments: Very minor vegetation, does not appear as though it would impede flow.

Downstream view from Whealan Rd. crossing.

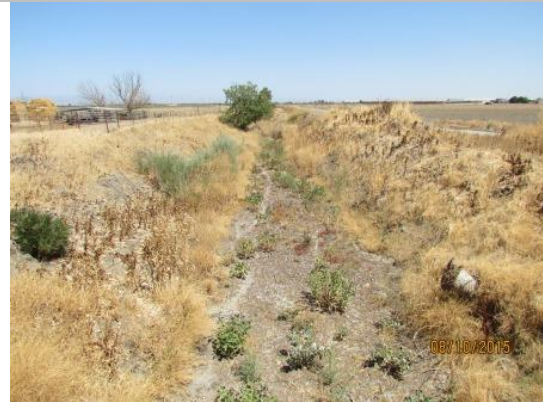
Photo 1 of 1 : CH_2015_NA0013_36_51_20150812_00042.jpg

Rating **	A	Issue No.	51	GPS Lat/Long
Issue Type +	Ma	Location *		37.272977 °
Category	Rivers, Channels & Designated Flood			-120.379054 °
Item	Vegetation & Obstructions			
DWR ID	DWR_NA0013_36_c _ 2012_51			
Action/Comments				
Inspector Comments: Minor vegetation present, but does not appear to impede flow.

Upstream view from Arboleda Dr. crossing.

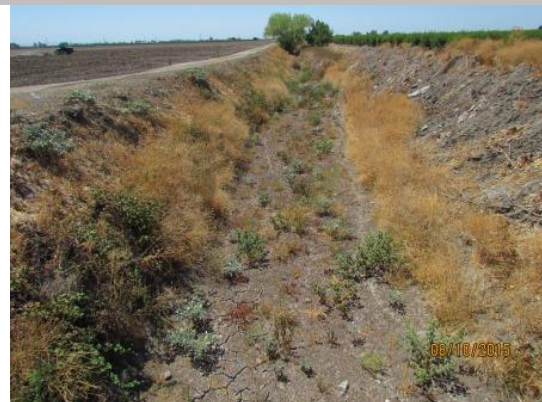
Photo 1 of 1 : CH_2015_NA0013_36_56_20150812_00043.jpg

Inspector Comments: Minor vegetation present, but does not appear to impede flow.

Downstream view from Arboleda Dr. crossing

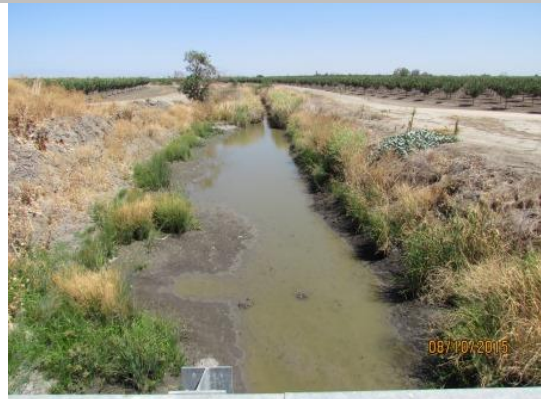
Photo 1 of 1 : CH_2015_NA0013_36_61_20150812_00044.jpg

Inspector Comments: Minor vegetation, but does not appear to be enough to impede flow.

Upstream view from Orchard Rd. crossing.

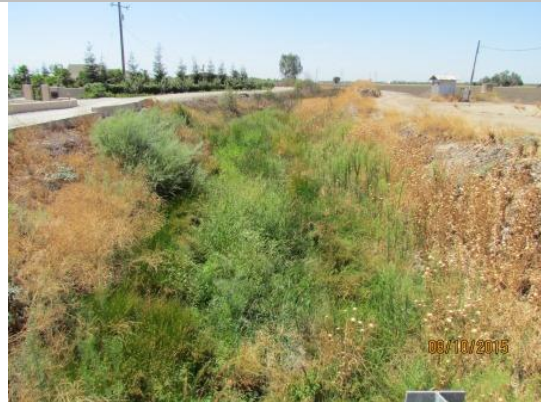
Photo 1 of 1 : CH_2015_NA0013_36_66_20150812_00045.jpg

Rating **	A	Issue No.	66	GPS Lat/Long
Issue Type +	Ma	Location *		37.269474 °
Category	Rivers, Channels & Designated Flood			-120.397390 °
Item	Vegetation & Obstructions			
DWR ID	DWR_NA0013_36_c _ 2012_66			
Action/Comments				
Inspector Comments: Minor vegetation, but does not appear to be enough to impede flow.

Downstream view from Orchard Rd. crossing.

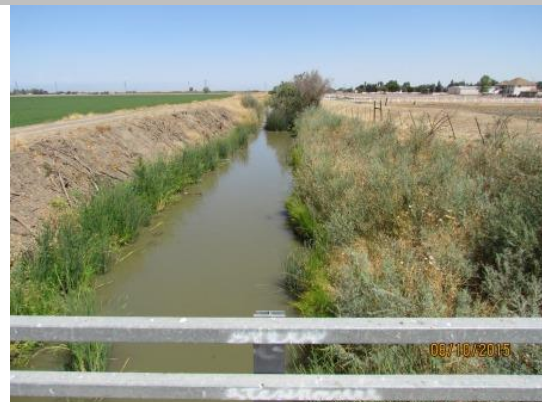
Photo 1 of 1 : CH_2015_NA0013_36_111_20150812_00046.jpg

Inspector Comments: Some woody vegetation on the left bank but may not impede flow. Recommend clearing at least 100 feet upstream.

Upstream view of Miles Creek from Miles Road.

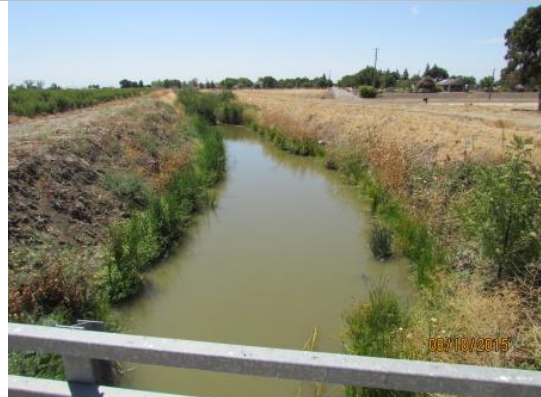
Photo 1 of 1 : CH_2015_NA0013_36_116_20150812_00047.jpg

Check Point / View				
Miles Rd / Down				
Rating **	A	Issue No.	116	GPS Lat/Long
Issue Type +	Ma	Location *		37.267270 °
Category	Rivers, Channels & Designated Flood			-120.415340 °
Item	Vegetation & Obstructions			
DWR ID	DWR_NA0013_36_c _ 2013_116			
Action/Comments				
Inspector Comments: Minor vegetation, but does not appear to be enough to impede flow.

Downstream view of Miles Creek from Miles Road.

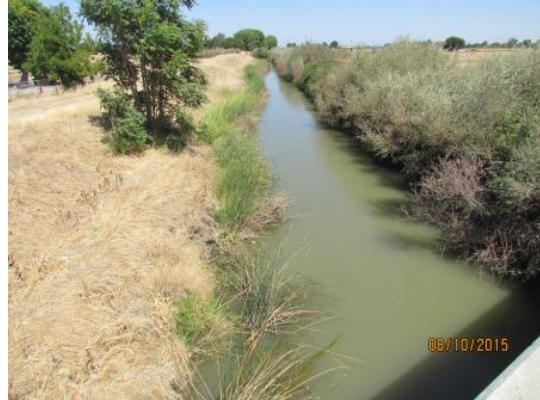
Photo 1 of 1 : CH_2015_NA0013_36_121_20150812_00048.jpg

Inspector Comments: Some woody vegetatoin present on the left bank which may impeded flow in the future. Recommend removing woody vegetation from the channel.

Upstream view of Miles Creek from Coffee St.

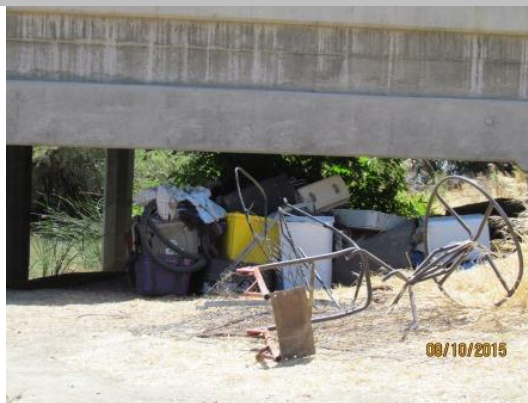
Photo 1 of 1 : CH_2015_NA0013_36_125_20150812_00049.jpg

View of the urban trash stored under the bridge.

Inspector Comments: Remove urban debris from underneath the bridge.

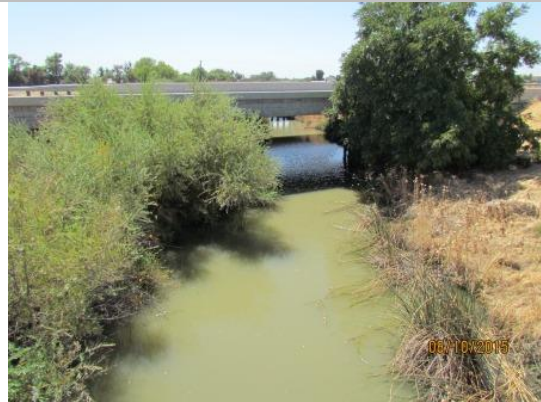
Photo 1 of 1 : CH_2015_NA0013_36_126_20150812_00050.jpg

Inspector Comments: Some woody vegetatoin present on the left bank which may impeed flow in the future. Recommend removing woody vegetation from the channel.

Downstream view of Miles Creek from Coffee St.
